**PRELIMINARY ASSESSMENT/
VISUAL SITE INSPECTION**

**BASF CORPORATION
CINCINNATI, OHIO
OHD 004 236 816**

FINAL REPORT

Work Assignment No.	:	R05032
EPA Region	:	5
Site No.	:	OHD 004 236 816
Date Prepared	:	February 7, 1992
Contract No.	:	68-W9-0006
PRC No.	:	209-R05032OH01
Prepared by	:	PRC Environmental Management, Inc. (Gabriel J. Rood)
Contractor Project Manager	:	Shin Ahn
Telephone No.	:	(312) 856-8700
EPA Work Assignment Manager	:	Kevin Pierard
Telephone No.	:	(312) 886-4448

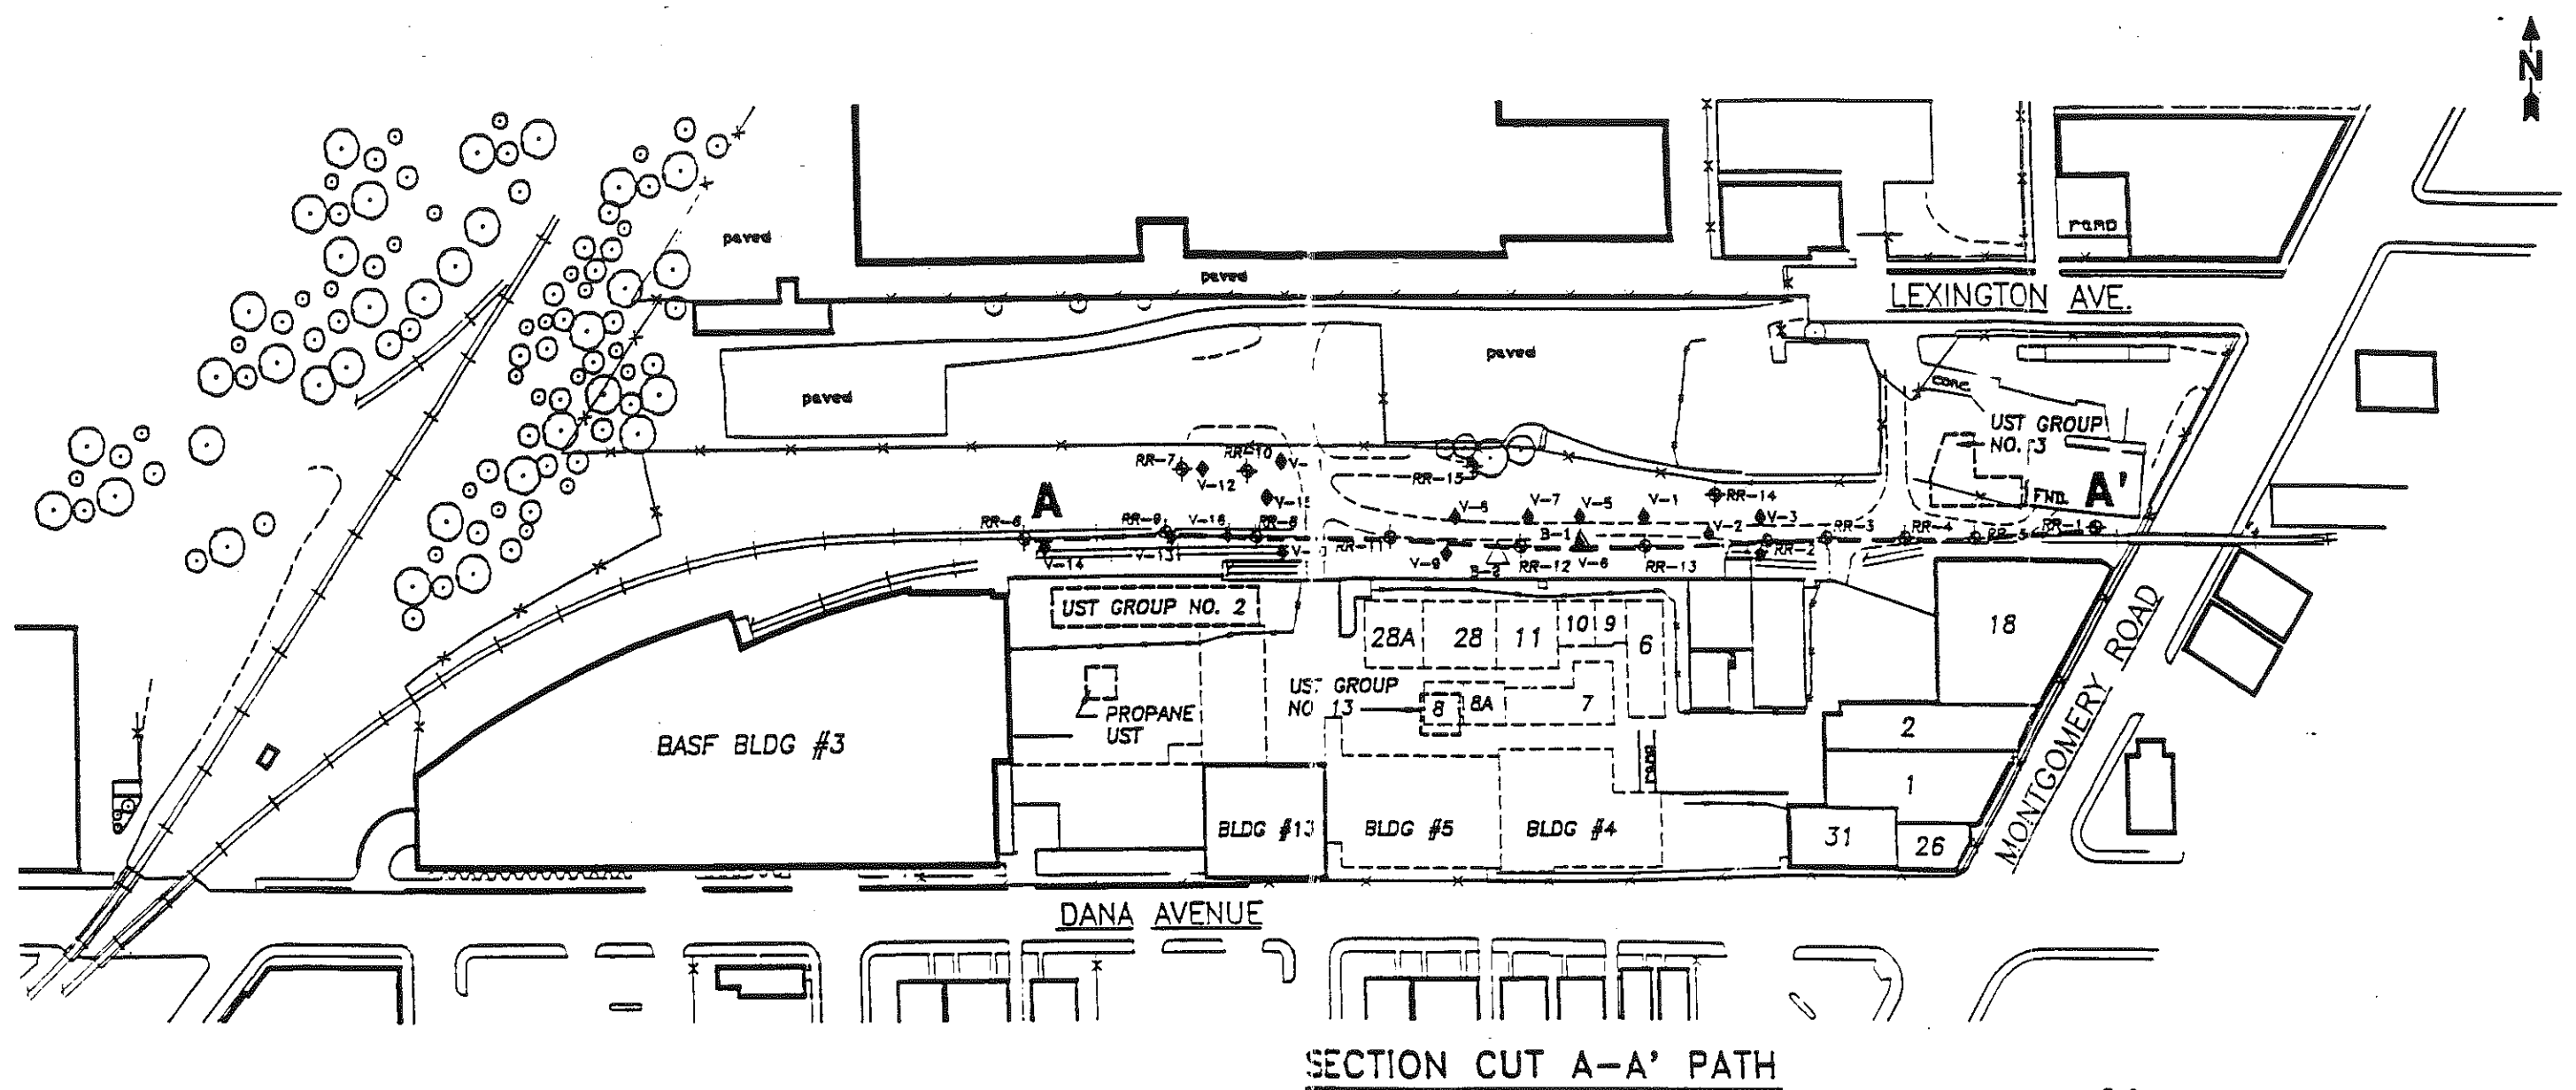
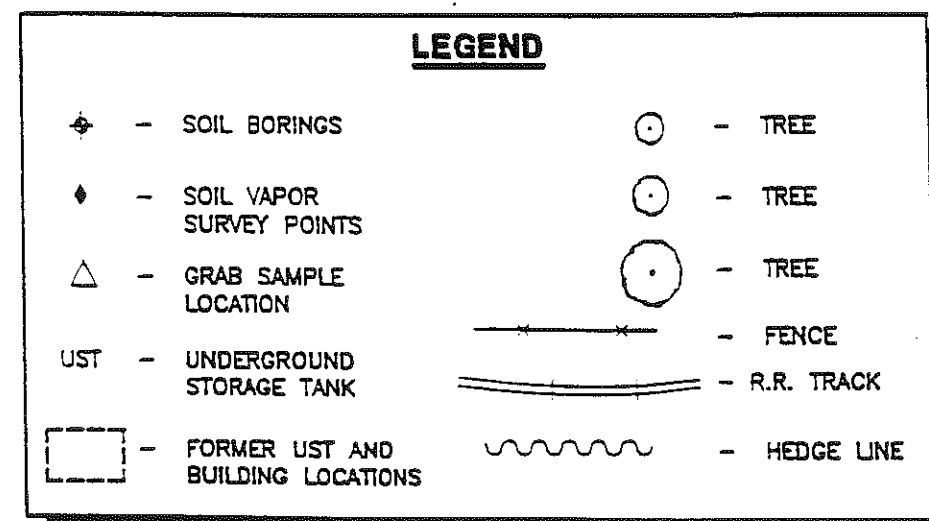
FIGURE 4
CROSS-SECTION A-A'

PET monitoring wells 1 through 7 indicated that there are two water bearing zones in the northeastern part of the facility. The perched water table is present in the uppermost silt at about 20 feet below grade. In the northeastern portion of the facility, perched water is found within the silt-clay unit, and the sand unit is dry to its base at 80 feet below ground surface. The lower aquifer is present at the base of a sand unit 75 to 80 feet below the surface. Along the southern boundary of the facility, the upper silt-clay unit is about 33 feet thick and overlies bedrock.

Permeability analysis of the silt material in the upper aquifer showed results of 7×10^{-7} to 6×10^{-9} centimeters per second. The degree of interconnection between the upper and lower aquifers is uncertain. Ground-water flow directions were not determined within the upper silt-clay unit in any of the investigations. However, ground-water flow direction is to the northwest, following regional preglacial drainage channels. (Groundwater Technology, 1991).

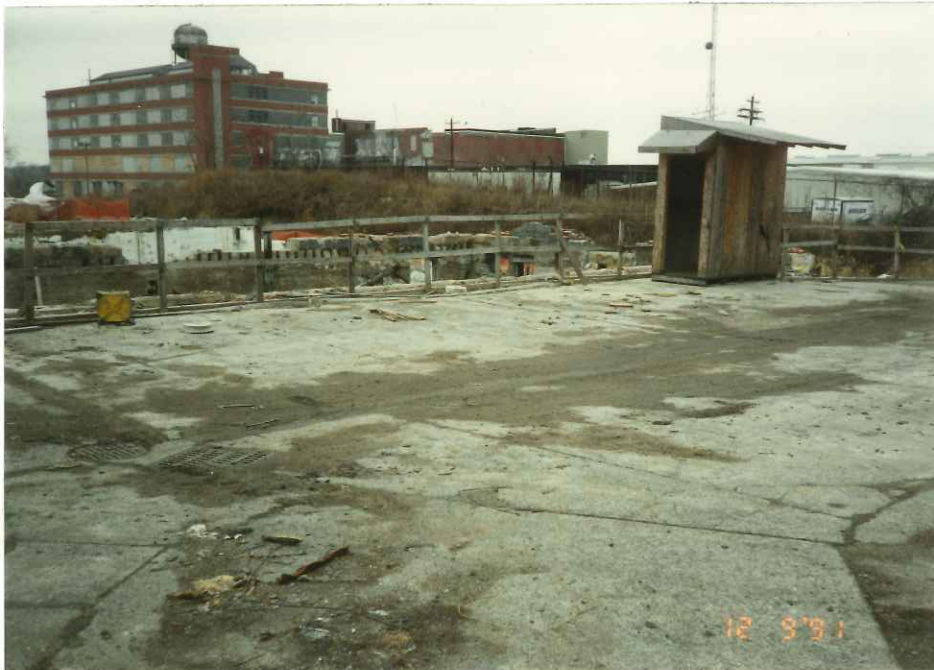
Location: SWMU 1
 Date: 12/09/91

The concrete berm has been removed from the pad, and large cracks are visible running down the center of the pad. Waste is no longer stored in this unit.

Photograph No. 1
 Orientation: Northwest
 Description: Remnants of the concrete pad; berm has been removed

Recommendations: Site-wide remediation is planned for the second quarter of 1992. PRC recommends EPA review and oversight of remediation plans and activities.

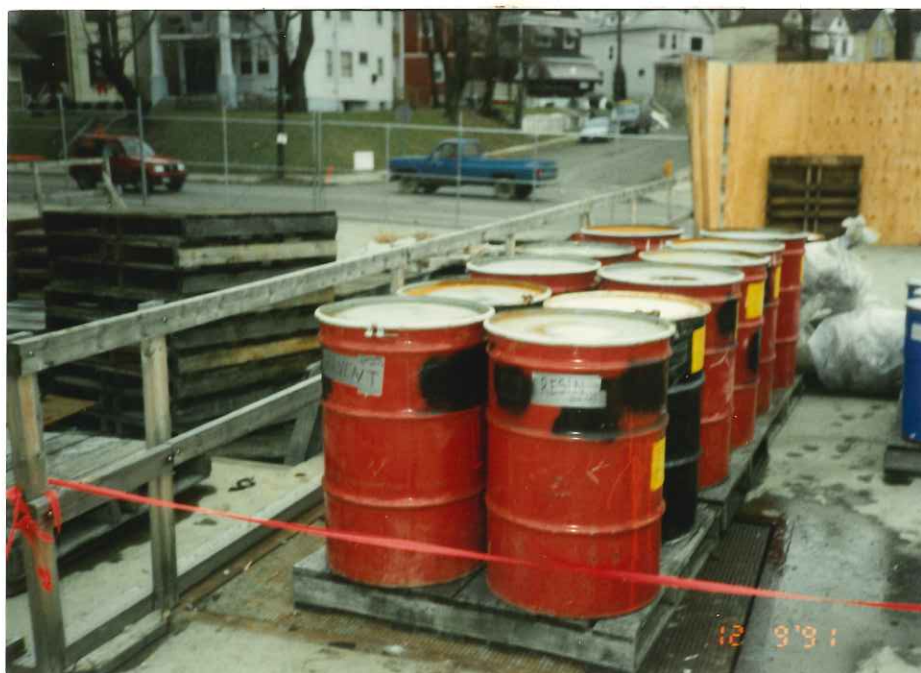
Location: SWMU 3
 Date: 12/09/91

Conclusions: This unit handles hazardous wastes in drums, and no secondary containment features exist. Some drums were stored above a floor scale in this unit during the VSI. Any spills could migrate towards the loading dock area about 5 feet from the drums. The loading dock area slopes toward Dana Avenue.

Photograph No. 2
 Orientation: South
 Description: Eleven, 55-gallon drums of D001 waste stored on wooden pallets; about six drums resting over a scale

Recommendations: Secondary containment should be added to the unit.
